Manhole Inspection Summary

Manhole # S01AA2004MH

Insp Date: **8/3/06 9:19 AM**

Location Address: **3215 PINKNEY RD**

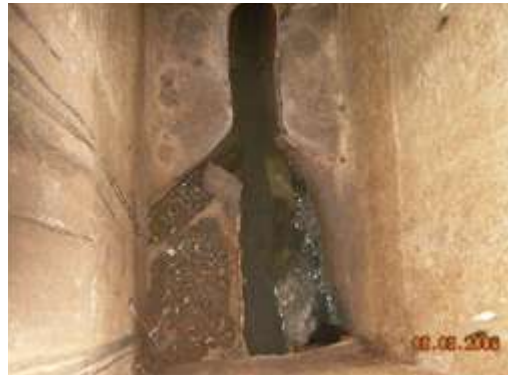
Top View

Infiltration: ☐ None ☒ **Joint** ☐ Cracks ☐ Mortar ☐ Roots ☐ Wall

☐ Parged ☒ **Debris** (not Condition related)

☒ **Debris** (not Condition related)

Corbel infiltration. Bench and Channel debris.

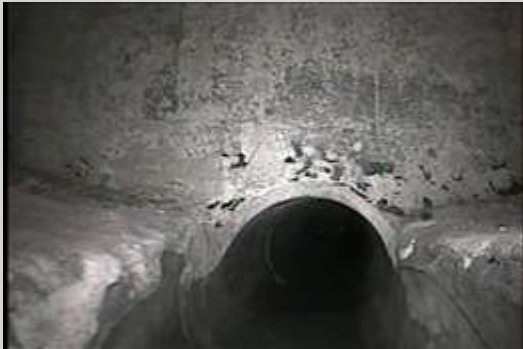
8 in. Circular Gravity Sewer Pipe Out @ 12 O'Clock

Infiltration: **None** Pipe Seal Cond: **Unknown**

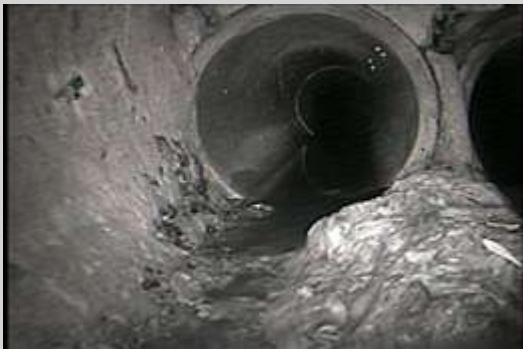
8 in. Circular Gravity Sewer Pipe In @ 5 O'Clock

Infiltration: **Evidence** Pipe Seal Cond: **Cracked**

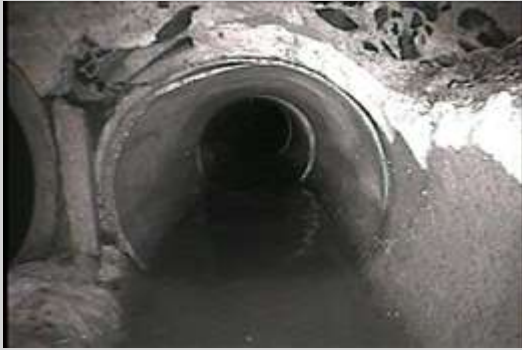
8 in. Circular Gravity Sewer

Infiltration: **None** Pipe Seal Cond: **Broken**

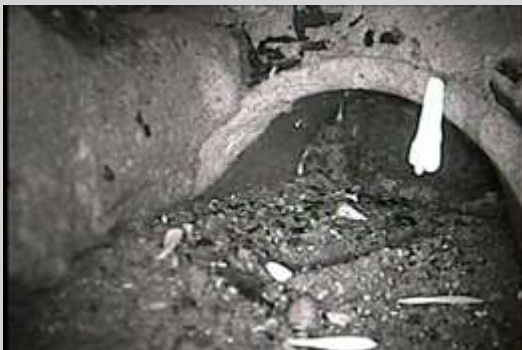
8 in. Circular Gravity Sewer

Connects To: **Stub connection / abandoned**
